# Manhole Inspection Summary

Manhole # S31MM1012MH

Insp Date: **3/26/07 2:00 PM**

**Location** Address: **4407 BEDFORD PL**

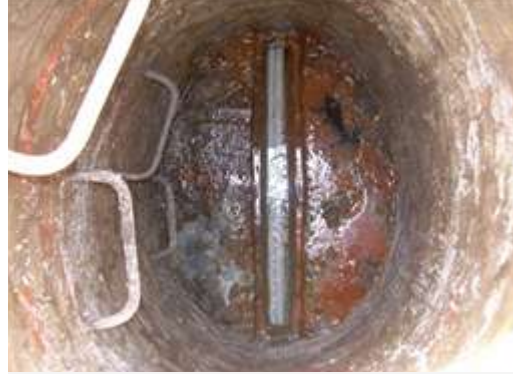
Top View

**Bench** ☒ Exists Material: **Brick** ☐ Parged ☒ **Debris** (not Condition related)

**Surcharge** ☒ **Evidence Of Surcharge** Depth: **1.5** (ft.) ☐ Active Surcharge Present

Evidence of surcharge - Bench debris.

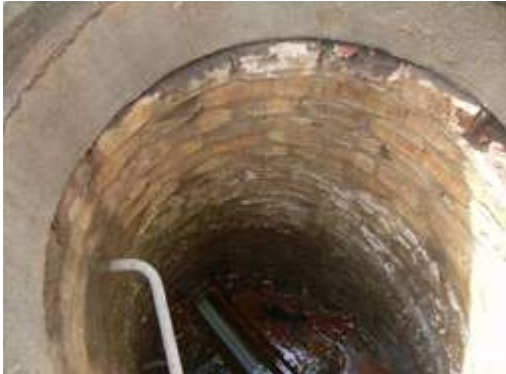
Defect

Condition: ☐ Sound ☐ Cracked ☐ Root Intrusion ☐ Loose Brick ☒ **Deteriorated**

Infiltration: ☐ None ☒ **Joint** ☐ Cracks ☒ **Mortar** ☐ Roots ☐ Wall

Infiltration: ☐ None ☐ Joint ☐ Cracks ☒ **Mortar** ☐ Roots ☒ **Wall**

Frame leaks. Adjustment deterioration and infiltration. Corbel and Barrel infiltration.

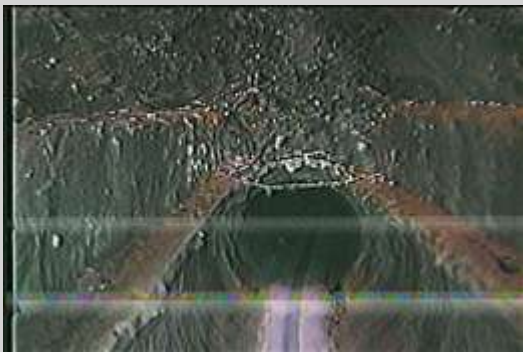
### 6 in. Circular Gravity Sewer Pipe Out @ 12 O'Clock

Invert Depth: **8.42** (ft.) Flow Characteristics: **Slow**

Infiltration: **None** Pipe Seal Cond: **Unknown**

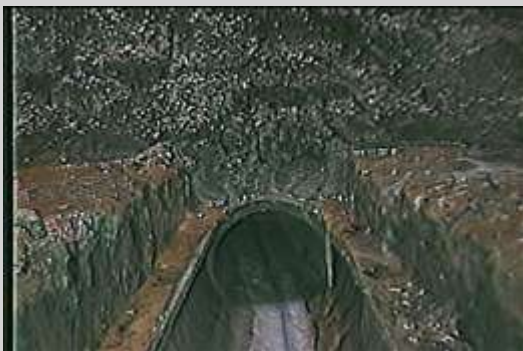
### 6 in. Circular Gravity Sewer Pipe In @ 6 O'Clock

Invert Depth: **8.41** (ft.) Flow Characteristics: **Fast**

Infiltration: **None** Pipe Seal Cond: **Sound**
